# PRE-CAST CONCRETE FIREPLACE DAMAGE AND REPAIR

Written by Dale W. Feb

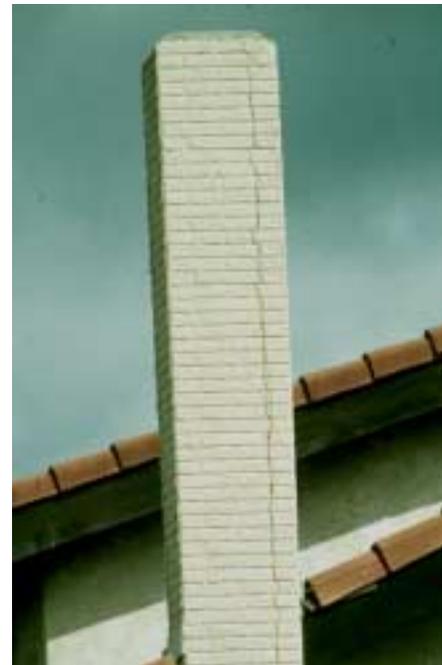
Although there are surface cracks in most concrete structures, the cracks of concern in the Pre-Cast Concrete Fireplace are addressed within the manufacturer's repair specifications. Cracks that do not pass through the walls into the interior areas may be repaired. However you must repair as per the manufacture's specifications. If the cracks are not repaired as per these specifications they have a higher tendency to return. These cracks are required to be cut out a minimum 1/2" wide by 2" in depth. Then a non-shrink grout with a minimum 2000 pound compression rating must be applied to replace the removed material. This repair method has proven to perform fairly well. The cracks found on the exterior of the fireplace structure are often caused by either the calcium chloride additive or seismic activity. The calcium chloride additive was placed in the concrete to speed up the curing time. The cracks caused by this calcium chloride usually follow the location of the vertical and horizontal steel reinforcement. When the calcium chloride is mixed with moisture a reaction occurs and rust scale develops on the steel reinforcement. This reaction and expansion of the steel reinforcement causes fractures in the concrete. These cracks always start on the exterior surface first.

Remember moisture is required to activate this process. A good coat of paint may help reduce moisture entry but does not eliminate this deterioration.

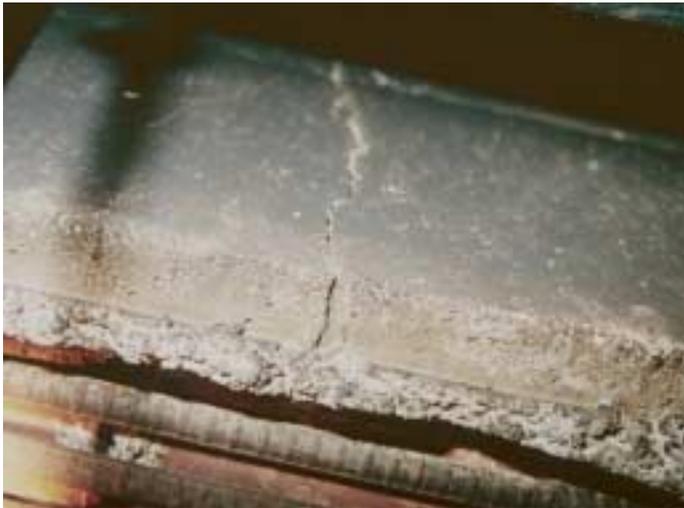
There are several weak points on this pre-cast concrete fireplace that are susceptible to a seismic event. The chimney, transition, walls of fireplace, as well as the insulation plate. The chimney has a tendency to crack horizontally at several locations. The transition is where the exterior shoulders of the fireplace meet the chimney. This is a common location for a crack due to the movement of the upper chimney. A horizontal crack within the interior flue can be found approximately six inches above the base of the flue liner. This crack correlates with the exterior damage found at the transition. The sides and rear of the fireplace are also very common points of failure. You may find one to three horizontal cracks per side on the fireplace. The rear wall of the fireplace may have both vertical as well as horizontal cracks. In many cases the horizontal cracks at the rear wall will meet up with the horizontal cracks at the side walls. Also note that the cracks on the interior firebox may be slightly different than the exterior cracks. This is due to the calcium aluminate firebox liner and the lightweight structural concrete being laminated together at the time of assembly. Remember that the manufacture states, "Cracks or punctures extending completely through a wall of the firebox area, throat area or chimney section **are not** subject to patching". Full removal and replacement of the fireplace may be required at this time. The true concern is that the cracks may allow the passage of heated gases into the combustible wall and create a fire hazard.

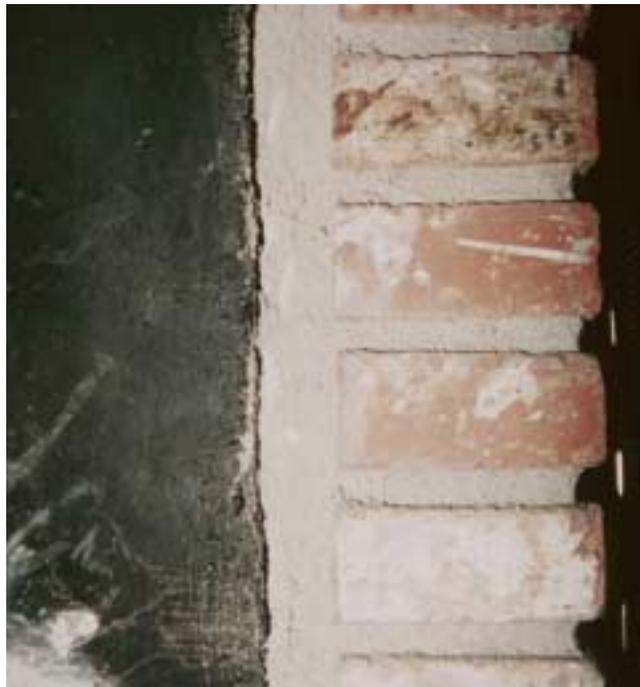
There is one additional location of concern that should be considered a high fire hazard. In many cases with the pre-cast concrete fireplaces there is a separation or gap between the face of the firebox and the decorative detail applied around the fireplace opening. This gap or crack located just inside the fireplace opening poses a real fire hazard. This separation could be due to seismic activity or simply the failure to close this area at the time of the veneer installation. In both cases this opening may cause a secondary chimney that will actually draw the heated gases into the wood framed wall. In time this exposure may cause ignition based on time of exposure, temperatures of the heated gases and the materials being exposed. This condition is easily corrected with the use of an approved material to block the passage of the heat.
