# PRE-CAST CONCRETE FIREPLACE DAMAGE AND REPAIR

Written by Dale W. Feb

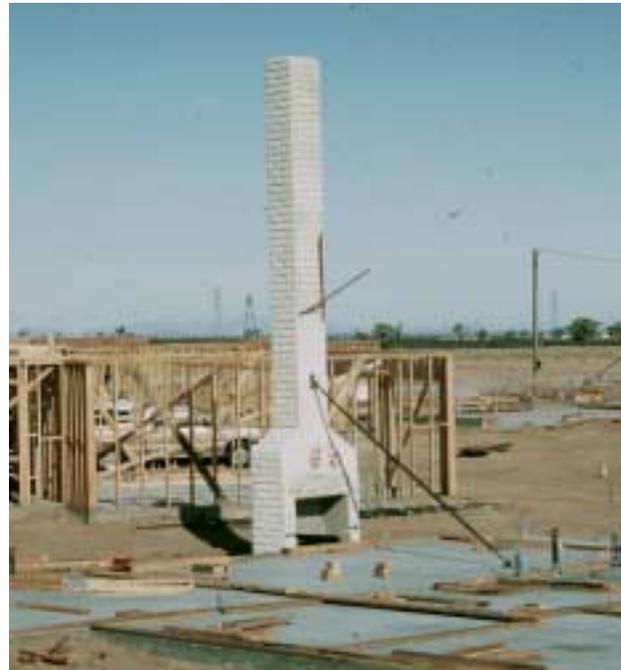
the footings were post-tension. Please be aware that the post-tension cables found within this concrete footing should **never** be cut during the removal of a damaged pre-cast concrete fireplace. Injuries may occur and the repair cost is substantial. Once the footing had cured, the brace was removed and the wood framed dwelling was constructed.

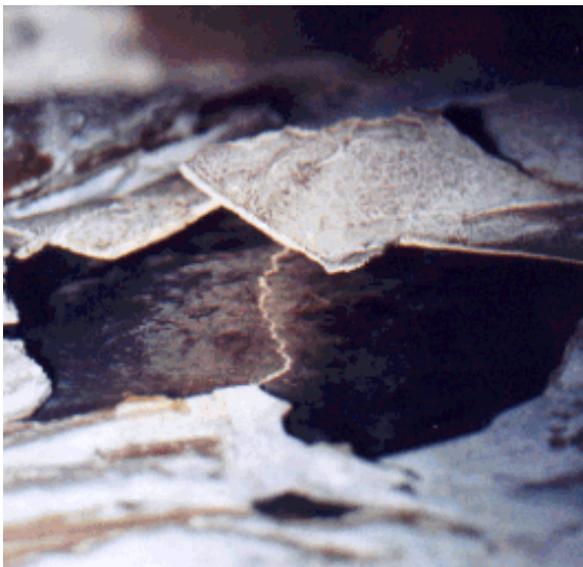
This means that if we decide to change or alter the existing pre-cast concrete fireplace outside the perimeters of the manufacturers' specifications then we invalidate the approval program required for the safe installation and operation of these fireplaces. The **incorrect type of repairs** that would fall into this category would be the replacement of the concrete chimney with a Class "A" chimney pipe, relining of the existing flue, the repair to a fractured "insulation plate" or the improper repair to exterior surface cracks. All of these incorrect repairs ultimately change the original structure, change the design or provide an unproven and/or potentially dangerous condition. Therefore any

repair that varies from these pre-cast concrete fireplace specifications has not been accepted by the Fireplace Manufacturer or the Courts that have upheld these documents. Both believe that a dangerous condition may exist without strict adherence to these specifications.
